Manhole Inspection Summary

Manhole # S33AA1004MH

Location Address: **3409 GREENWAY**

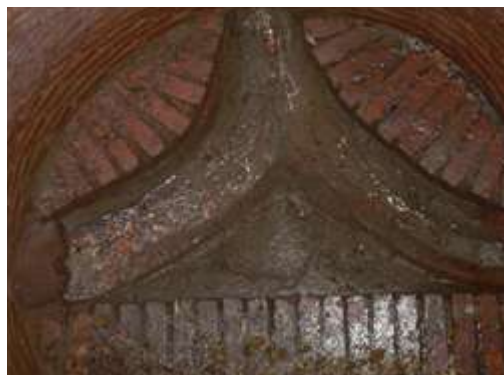
Top View

Bench debris.

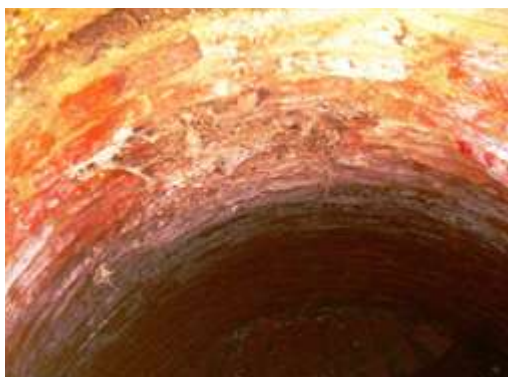
Defect

Adjustment infiltration. Corbel root intrusion and infiltration.

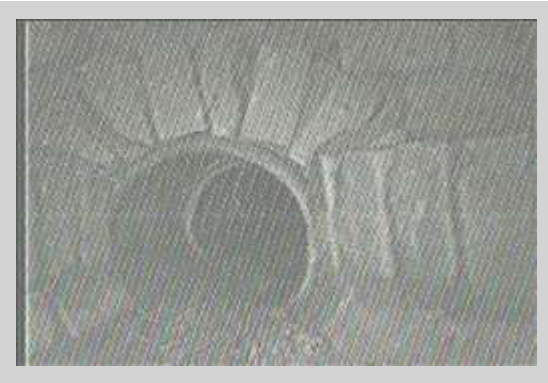
Pipe Out @ 12 O'Clock

Barrel deterioration and infiltration. Channel deterioration.

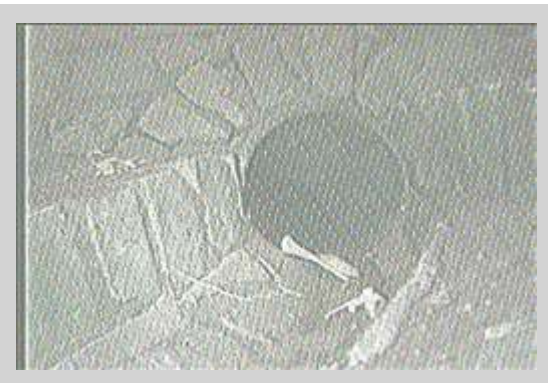
Pipe In @ 3 O'Clock

Channel deterioration and root intrusion.

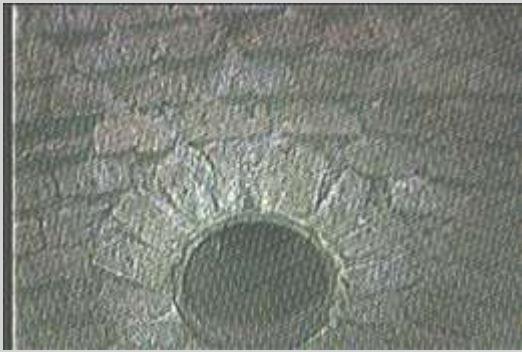
Pipe In @ 9 O'Clock

Barrel deterioration and infiltration.

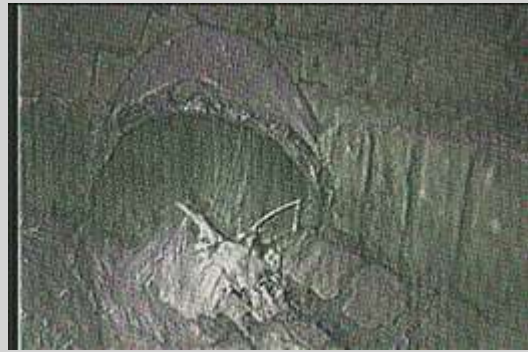
Drop In @ 9 O'Clock

Barrel deterioration and infiltration. Channel deterioration.
